# TOTUS saves five 130 kV bushings in Canada

**Evidence:** Increase of Power Factor and Partial Discharges in the bushing

**Action:** Both bushings replaced after offline tests confirmed the online results

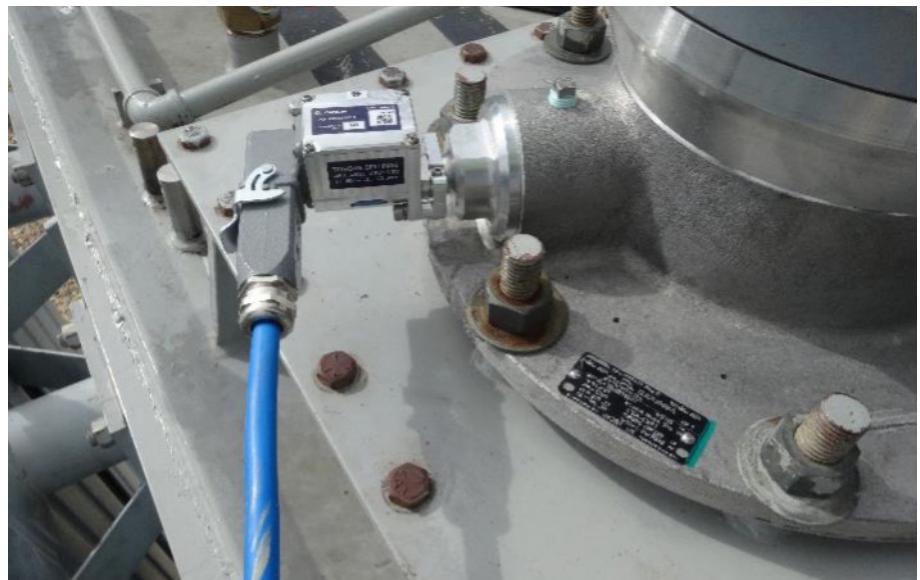
Figure 1: Camlin bushing sensor installed at the bushing test tap to detect both Partial Discharges and changes in Capacitance and Power Factor.

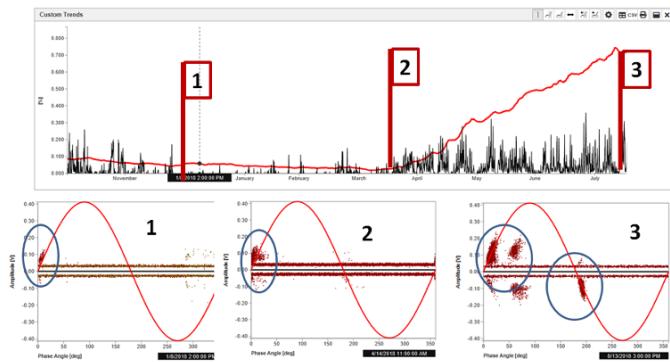
Figure 1 shows the increasing trend of the relative Power Factor, estimated from the variation of the angles of the currents (red trend line). The Power Factor started to raise in March showing an increment of around 0.7%, thus justifying further investigation. It is interesting to note the black trendline which shows the number of PD per second detected in the same bushing (X3): after some sporadic discharge between October and April, PD started to be more repetitive, correlated with a simultaneous increase of the Power Factor in the same bushing.

The TOTUS system identified the source of PD to be located in the bushing and by analysing the Phase-Resolved Partial Discharge (PRPD) pattern it was possible to speculate that the PD was likely due to the presence of particles in oil.

Figure 2: Hourly PD evolution in bushings X3 on LV 130kV side, correlated with Tandelta Increase over the time, before switching the transformer off.

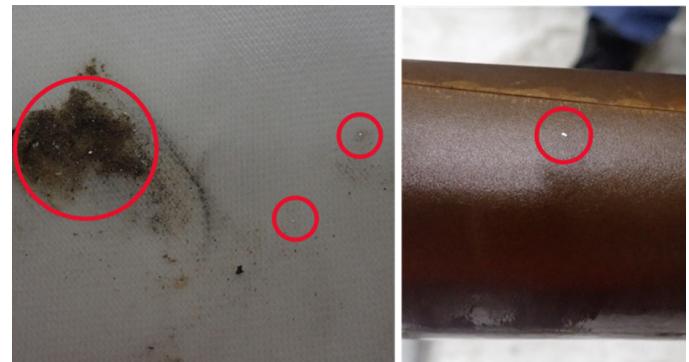
The inspection showed presence of metallic contamination. DGA was planned on all the bushings of the same batch that were not equipped with online monitoring highlighting that 3 other bushings had abnormal H<sub>2</sub> values which led to the replacement of a total of 5 bushings.

Due to poor manufacturing, metallic particles were trapped in the bushing and free to move when, at higher temperature, the oil viscosity higher. This was generating Partial Discharges and increase of bushing losses, thus resulting in a Power Factor increase.

Figure 3: Findings of metallic particles in the bushing during visual inspection.

The utility decided to de-energize the transformer and perform the offline test including DGA and oil quality. The results confirmed the abnormal condition of the bushings, showing poor oil quality values and high DGA readings for Hydrogen, exceeding 9000 ppm. The bushings were planned for immediate replacement and visual inspection.
