CONNECTING DATA TO DECISIONS

Case Studies - Volume 1

Linking Total Transformer Monitoring & Actionable Information
to Drive Business Value for Utilities

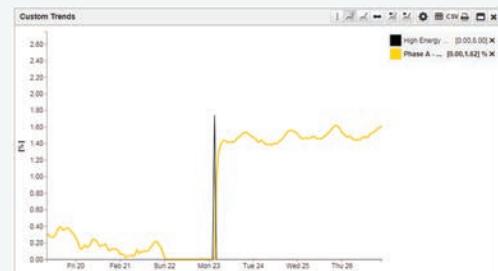
Figure 1. Capacitance increase in bushing A1 and high energy event recorded at the same time.

It was then found that at the precise moment of the bushing capacitance increase, a high energy event (partial discharge activity with significantly high magnitude, generally equal or higher than 20 V peak-peak [6]) was recorded in the same phase (from same sensor) by the online monitoring system. In this case, the recorded event had just 8 pulses per second and it happened just once. The fact that this event was recorded in conjunction with the capacitance increase was an important detail that prompted an additional offline test: oil sampling from the bushing and Dissolved Gas Analysis (DGA). Table 2 reports the results of the DGA analysis for bushings A and C. It can be clearly seen that the amount of acetylene in bushing A is well above the tolerance values, being 76 ppm; while level of acetylene in bushing C was zero, as expected.

Following the results shown in Table 2, South Korean Transmission Company promptly planned and executed the bushing replacement within a few months, thus saving the bushing from a potentially catastrophic incident. It must be noted that both the capacitance change and the repetition rate of the high energy event were quite small in terms of absolute magnitude. But being able to detect both these phenomena online and see that they occurred in the same moment provided crucial information enabling South Korean Transmission Company to take a very successful action.

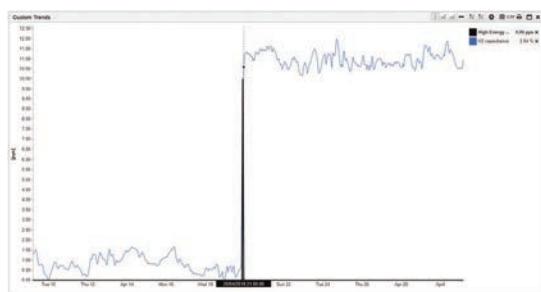
By looking at the data it was observed, once again, that a high energy event was recorded in conjunction with the capacitance increase in the same phase. Figure 1 shows the recorded data (not averaged, published every hour) and the partial discharge pattern. The event was characterized by impulses with significant magnitude (60 V peak-peak) and very small repetition rate (just 6 pulses per second), almost describing a sudden arcing activity. Recognizing the same correlation pattern (capacitance change + high energy event) seen in the KEPCO case, it was then suggested to the utility to take an oil sample of the bushings.

Figure 1. Capacitance increase in bushing H2 and high energy event recorded at the same time

Table 1 reports the comparison between the DGA from bushing H2 and H1, showing the acetylene concentration exceeding 20 ppm in the bushing where the capacitance change and high energy events have been detected, confirming the online analysis and enabling the utility to immediately plan the bushing replacement. The correlation of partial discharges and bushing monitoring data, along with proper offline tests, was successful in identifying the problem at a very early stage, optimizing the maintenance (in this case truly condition-based) and ultimately saving the transformer.

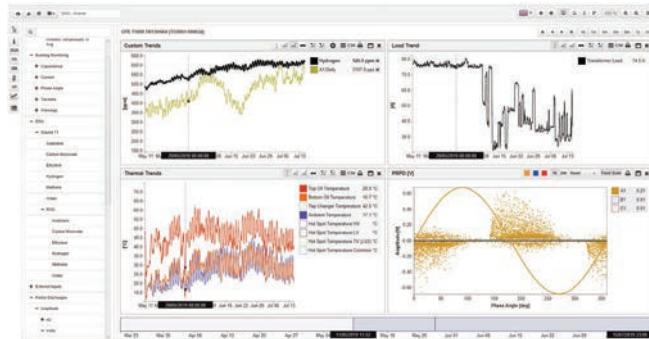
- Looking at all the data collected by the holistic monitoring system, it is possible to see that there is almost no correlation to load temperature or humidity. The gas generation and partial discharge activity are not influenced by the load, nor by temperatures and humidity.

Figure 2. Online results synchronized and visualized in a way to enable further investigation on the possible correlation

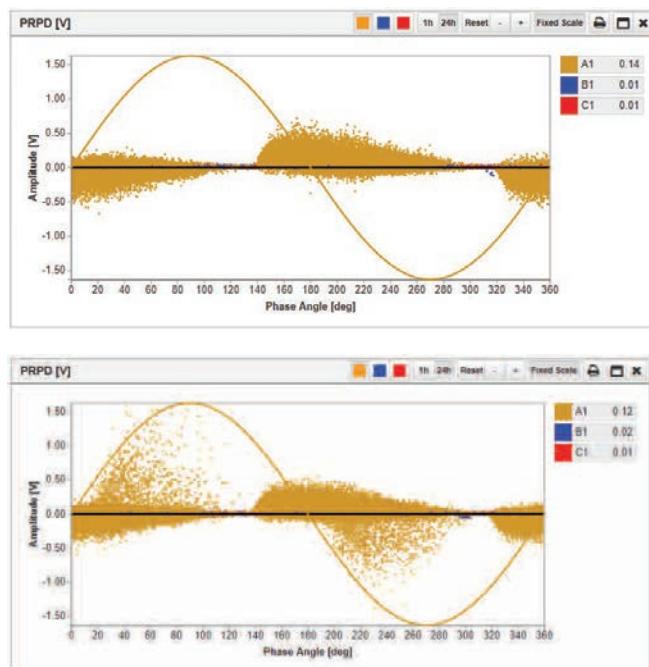
- The first is always present and constant in amplitude and repetition rate (5000 pps) with indirect polarity and typical for defects inside the main tank (including the bushing turrets, i.e. whatever is outside the bushing core). This activity has no cross coupling with the other phases which means that the source is far from the other two phases or very close to the partial discharge sensor.

- The second is sporadic, with smaller repetition rate (in the range of 1000-2000 pps) and with direct polarity indicating that it could be inside or very close to bushing A. The overall partial discharge activity was increasing over time in terms of repetition rate, indicating that the active defect was in phase A.

- From the phase-resolved partial discharge (PRPD) pattern it was difficult to identify the partial discharge source, however similar shapes of the pattern had been recorded when the oil treatment was not conducted properly leaving small air bubbles trapped, or when small puncturing activities were present in the paper insulation on the top of the winding column (e.g. in the stress ring).

Figure 3. PRPD pattern of the stable partial discharge activity in Phase A1 (left) and the sporadic activity overlap (right)

- Keep the transformer monitored and under control in order to analyse the gas and partial discharge development during the next few months.
- Plan the gasket replacements in order to perform a proper oil treatment and refilling under vacuum to remove any possible trapped bubble.
- Agree that maintenance was to be planned. However, this could be deferred to the next stop of the generator considering that:
 - the overall picture provided by the online monitor indicated that the transformer was not in a critical condition, and
 - the transformer was continuously monitored so any unexpected change in the condition would promptly notify the Subject Matter Expert.

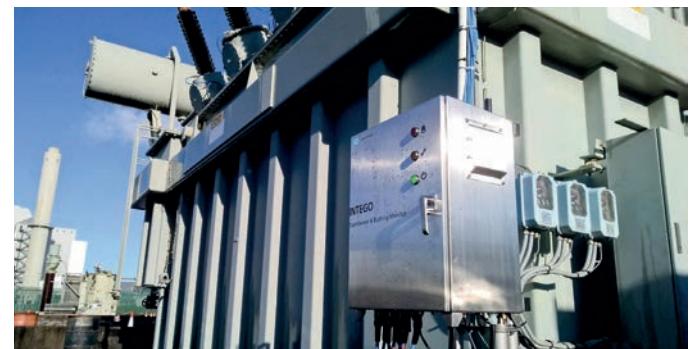
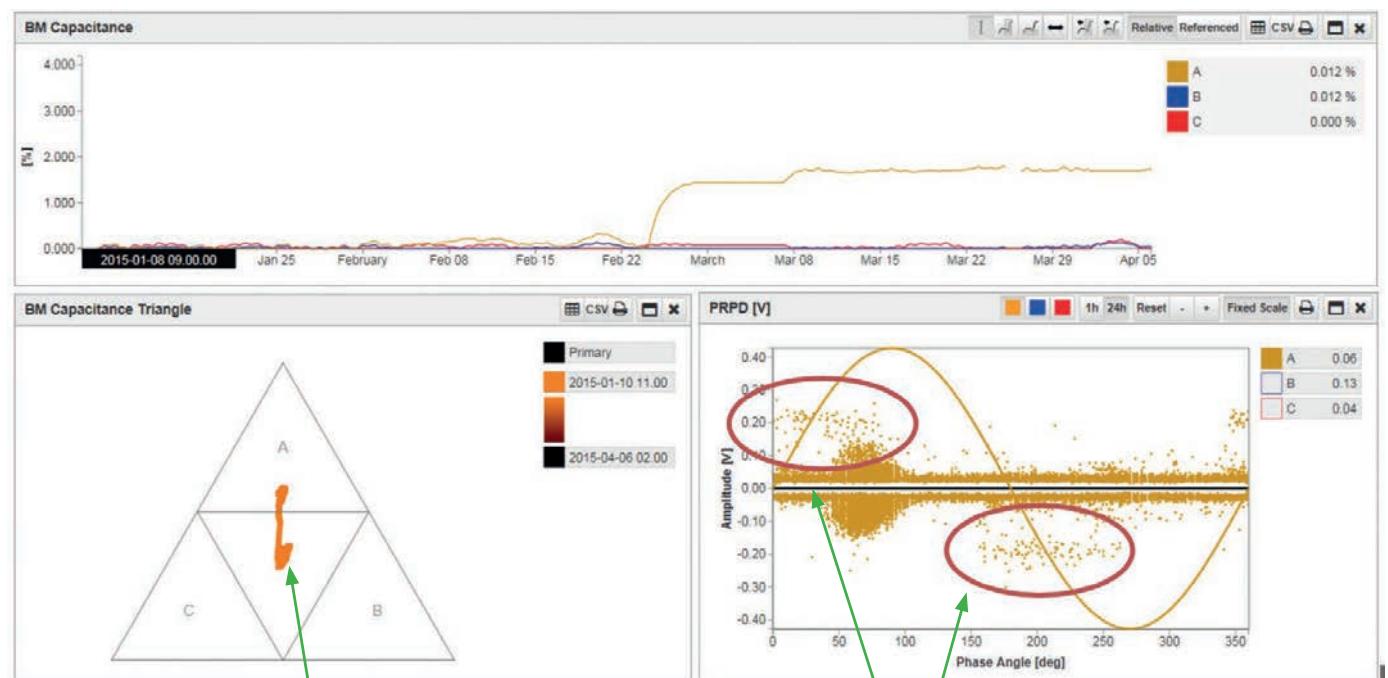
Deviation recorded was minimal (1.5%) but consistent with a short circuit between 2 layers for a 345 kV bushing provided with >50 layers inside the condenser core.

CAMLIN Capacitance Triangle showing Capacitance change in Phase A

PRPD Pattern showing PD in Bushing

In depth analysis over partial discharge records revealed that High Energy Events occurred in correspondence of the sudden capacitance change.

- Bushing Offline Capacitance Test
- Bushing Offline TanDelta Test
- Bushing Oil Dissolved Gas Analysis.

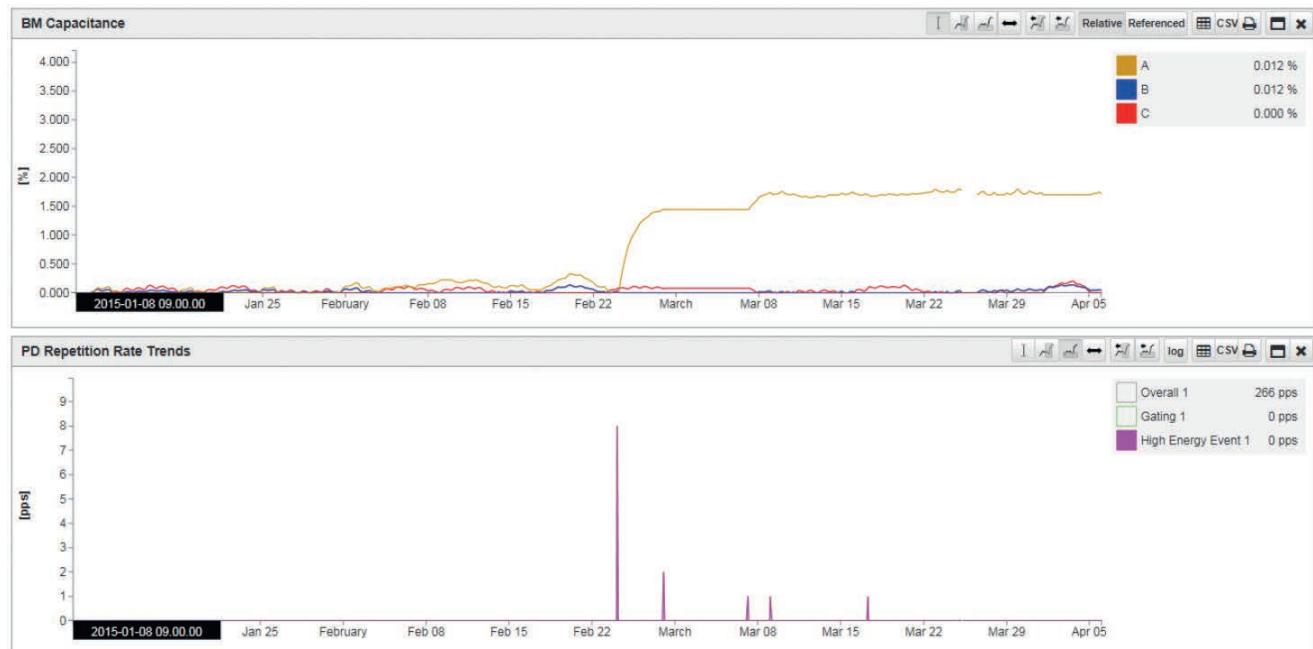
High Energy Event (HEE) is defined as a PD event with very high amplitude (much higher than 10 Vpp and several tens, even hundreds, of nC) which may occur with intermittent behavior. The occurrence of HEE confirmed the increase on the relative Capacitance trend.
