Early Detection and Replacement Saves Two 69 kV Bushings for APAC Utility

CASE STUDY

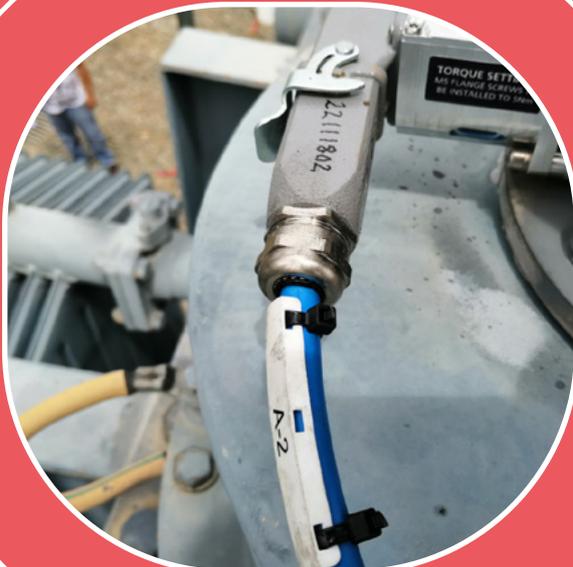
Figure 1:

Camlin bushing sensor installed at the bushing test tap to detect both Partial Discharges and changes in Capacitance and Power Factor.

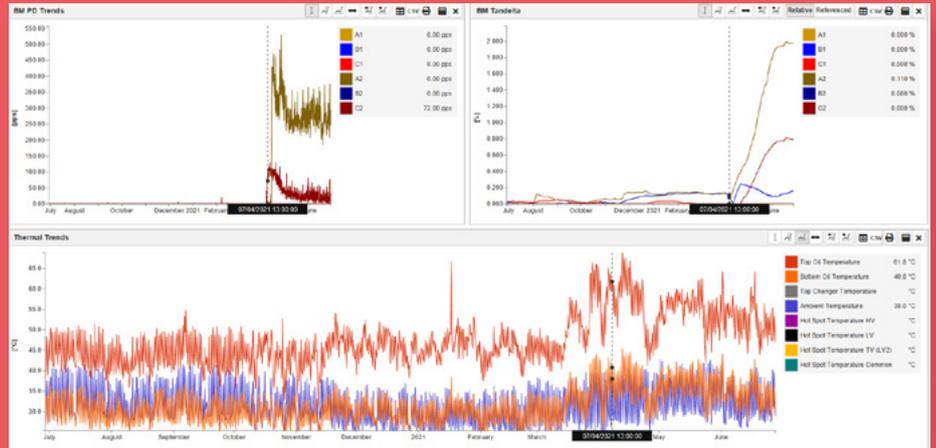
Figure 2:

In March 2021, the transformer went through a sustained high-load period lasting almost a week, driving oil temperatures significantly higher. During this period, TOTUS recorded rising CO and CO₂ levels that tracked with temperature but remained within safe limits. At the same time, bushings A2 and C2 on the 69 kV side showed a gradual increase in Power Factor and a clear step-change in partial discharge activity.

Even when the load was temporarily reduced, the degradation trend did not stabilise, and Power Factor continued to rise, a clear indication of persistent deterioration. Crucially, TOTUS was able to accurately localise the PD activity to the bushings rather than the main tank, pinpointing the source of risk and enabling precise, targeted intervention.

PD trend in all bushings (Top left) showing a step increase only in bushings A2 and C2 together with the slow Tandelta increase (Top right) in the same bushings. Both phenomena are correlated to the Top Oil increase (Bottom)

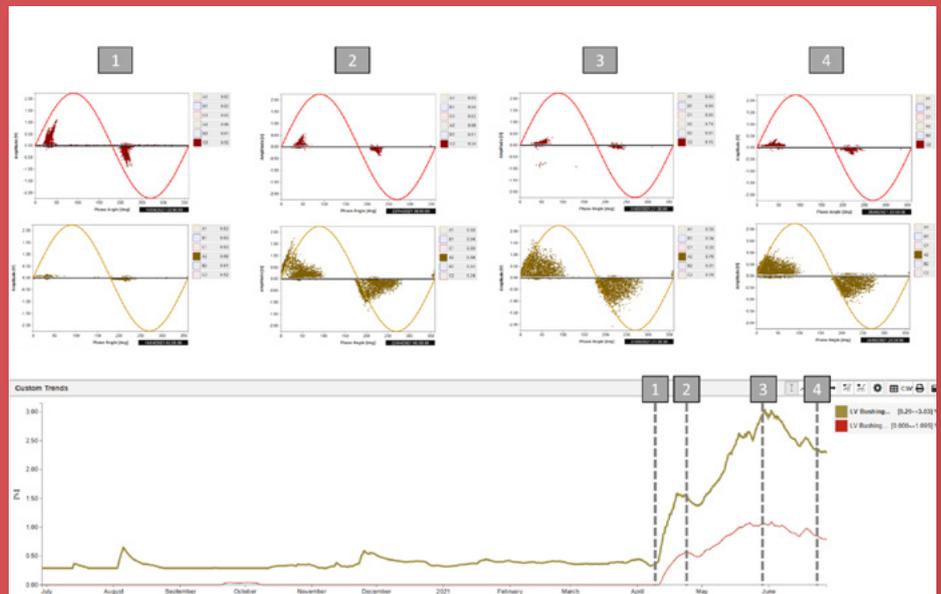
Figure 3:

Capacitance pF	Power Factor %
A1	350.8	0.241
B1	343.5	0.266
C1	345.8	0.272
A2	313.8	3.085
B2	331.4	0.269
C2	331.9	1.793

Hourly PD evolution in bushings A2 and C2 on LV side, correlated with Tandelta Increase and Decrease over the time, before switching the transformer off.

With the visibility of data provided by TOTUS, the utility de-energised the transformer and carried out targeted offline testing. This confirmed abnormal Power Factor readings on two bushings, 3.0% on A2 and 1.8% on C2, indicating emerging insulation deterioration. Based on this evidence, the utility prioritised proactive replacement of both bushings before an in-service failure could occur.
