# Online Monitoring Identifies Rapidly Escalating Fault in 120 kV RIP Bushing

CASE STUDY

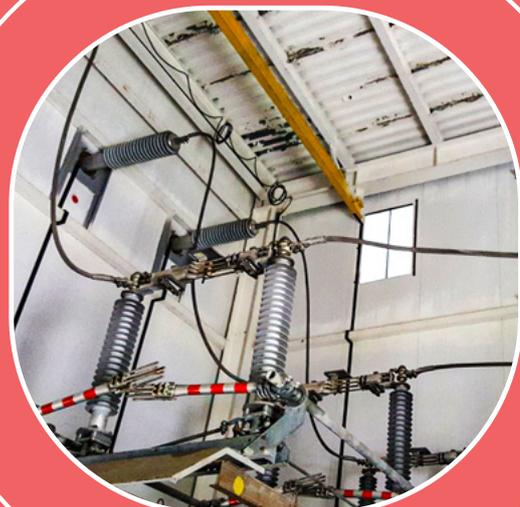
### Figure 1:

At this indoor substation in Russia, six horizontally mounted 120 kV RIP wall bushings were operating in a critical environment where failure could have caused:

Resin Impregnated Paper Wall bushings, horizontally mounted at an indoor substation.

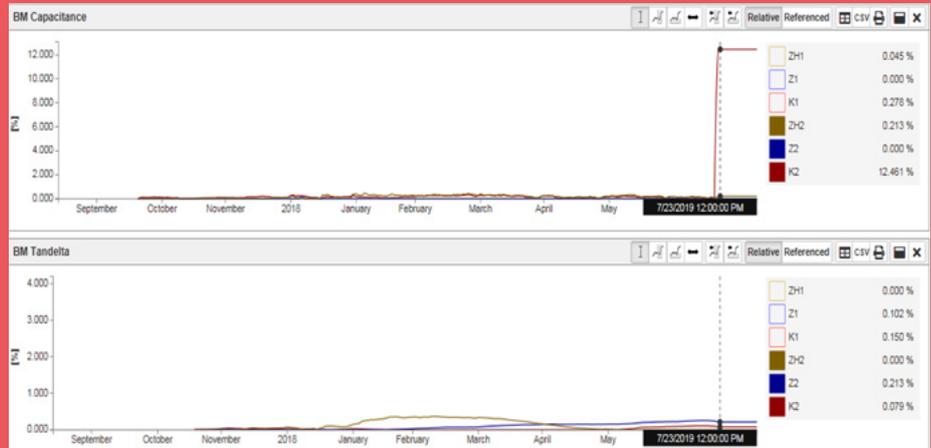
**Figure 2:**

In the summer of 2019, TOTUS detected a sudden ~12% increase in capacitance on the K2 phase bushing – a strong indicator of structural deterioration. A review of historic partial discharge data showed that PD activity had been present for roughly a month beforehand, with signatures consistent with voids or internal delamination. Importantly, the discharge source was accurately localised within the K2 bushing rather than elsewhere in the transformer.

Together, the early PD activity followed by a sharp step-change in capacitance provided a clear warning of a developing internal bushing fault that was likely to escalate rapidly without timely intervention.

Abrupt increase in Capacitance ~12.5%, observed on 120kV RIP Wall Bushing.

With visibility of critical information, the utility scheduled a controlled outage to carry out offline diagnostics. Testing confirmed a ~12% increase in capacitance, fully consistent with the online findings, validating the emerging risk. Based on this evidence, the utility prioritised immediate replacement of the K2 bushing.

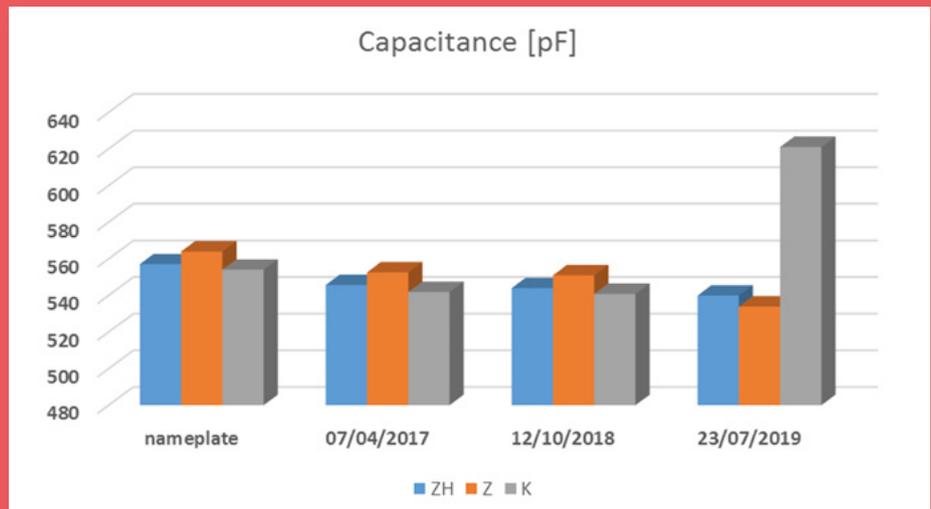
**Figure 3:**

Offline Capacitance and PF tests on RIP 120kV Wall Bushings. Capacitance increase was approximately 10-12% from prior maintenance tests; consistent with change detected by the TOTUS online Bushing Monitoring.

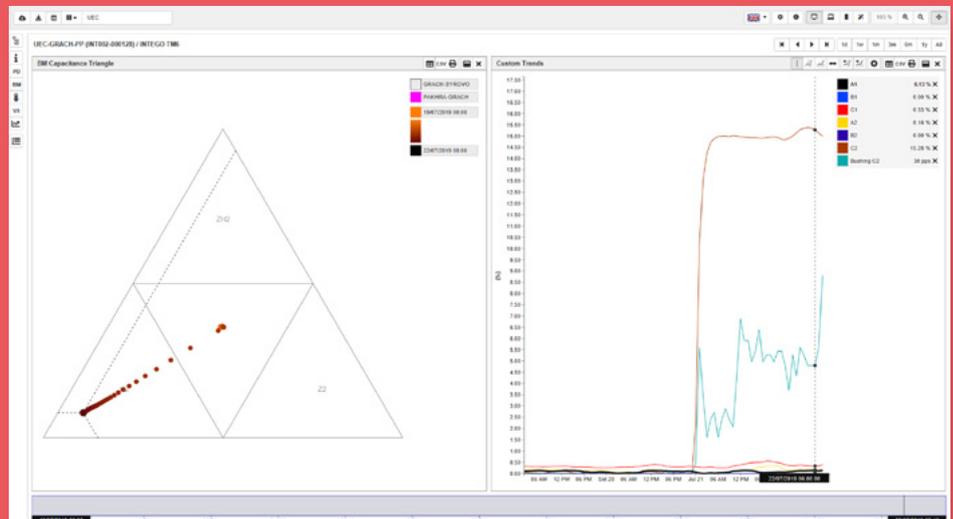
**Figure 4:**

TOTUS online PD shows a developing change in online PD at the moment a capacitance change occurred in the bushing. The Camlin PD triangle indicates the transition and correctly assigns the PD activity on the K2 bushing.

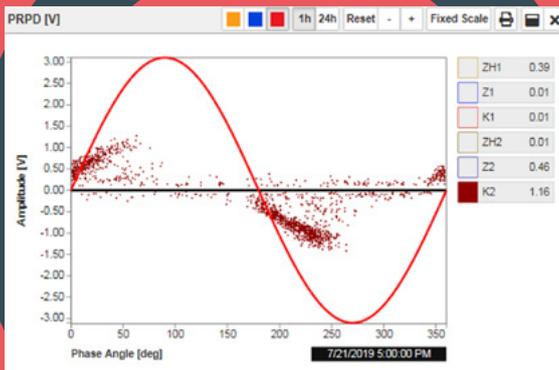
**Figure 5:**

TOTUS online PD shows a phase-resolved PD pattern consistent with patterns typical of voids or delamination in solid resin, and is a typical defect type in RIP bushings.
