# A €9,000 Intervention That Prevented a €2M Catastrophic Failure for a Leading French Utility

CASE STUDY

Preventing Transformer Failure in a Critical Hydro Asset

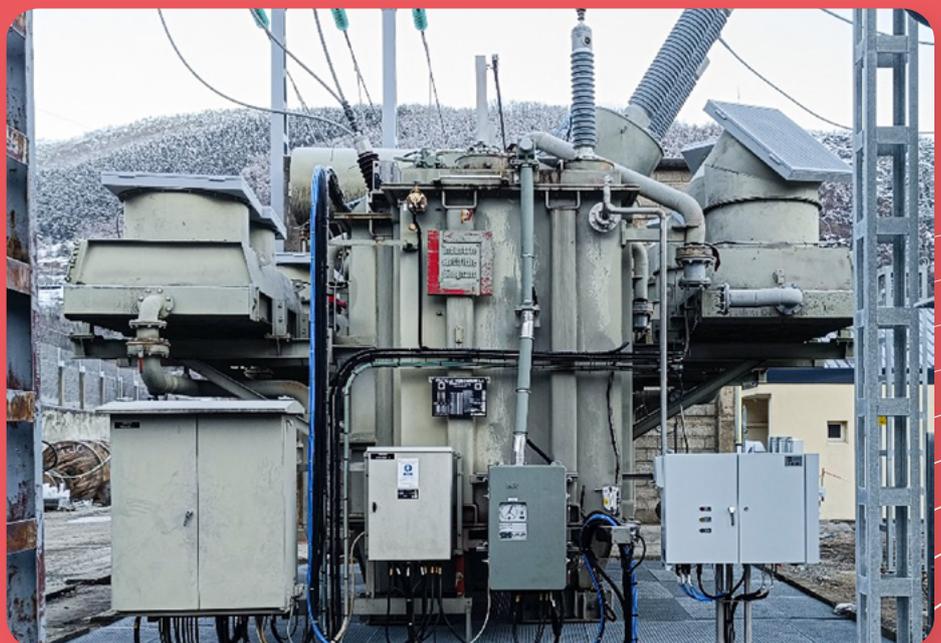
**Figure 1:**

Transformer with TOTUS installed

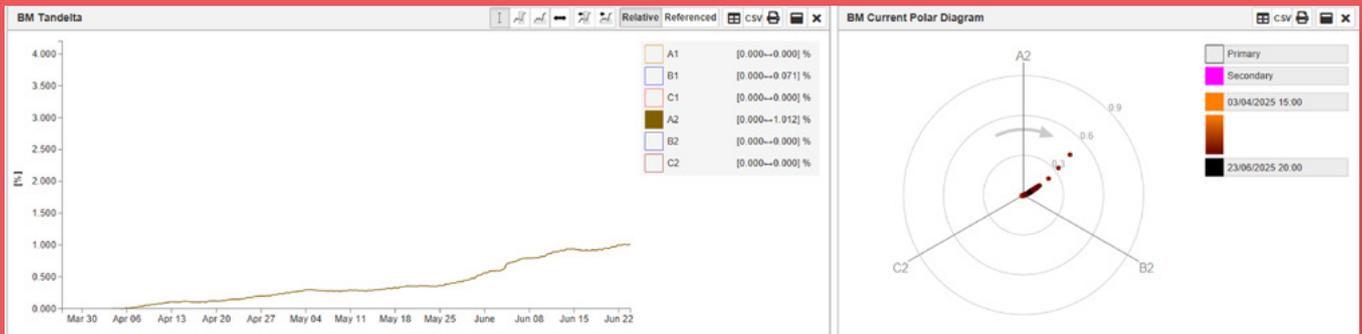
**Figure 2:**

Findings revealed a progressive increase in power factor in late June, exceeding alarm thresholds, while capacitance deviations closely mirrored top oil temperature, indicating thermally driven insulation degradation and suggesting advanced dielectric ageing that required further investigation.

Dissipation factor increases in secondary A-phase bushing (left), and polar plot of secondary winding's bushings.

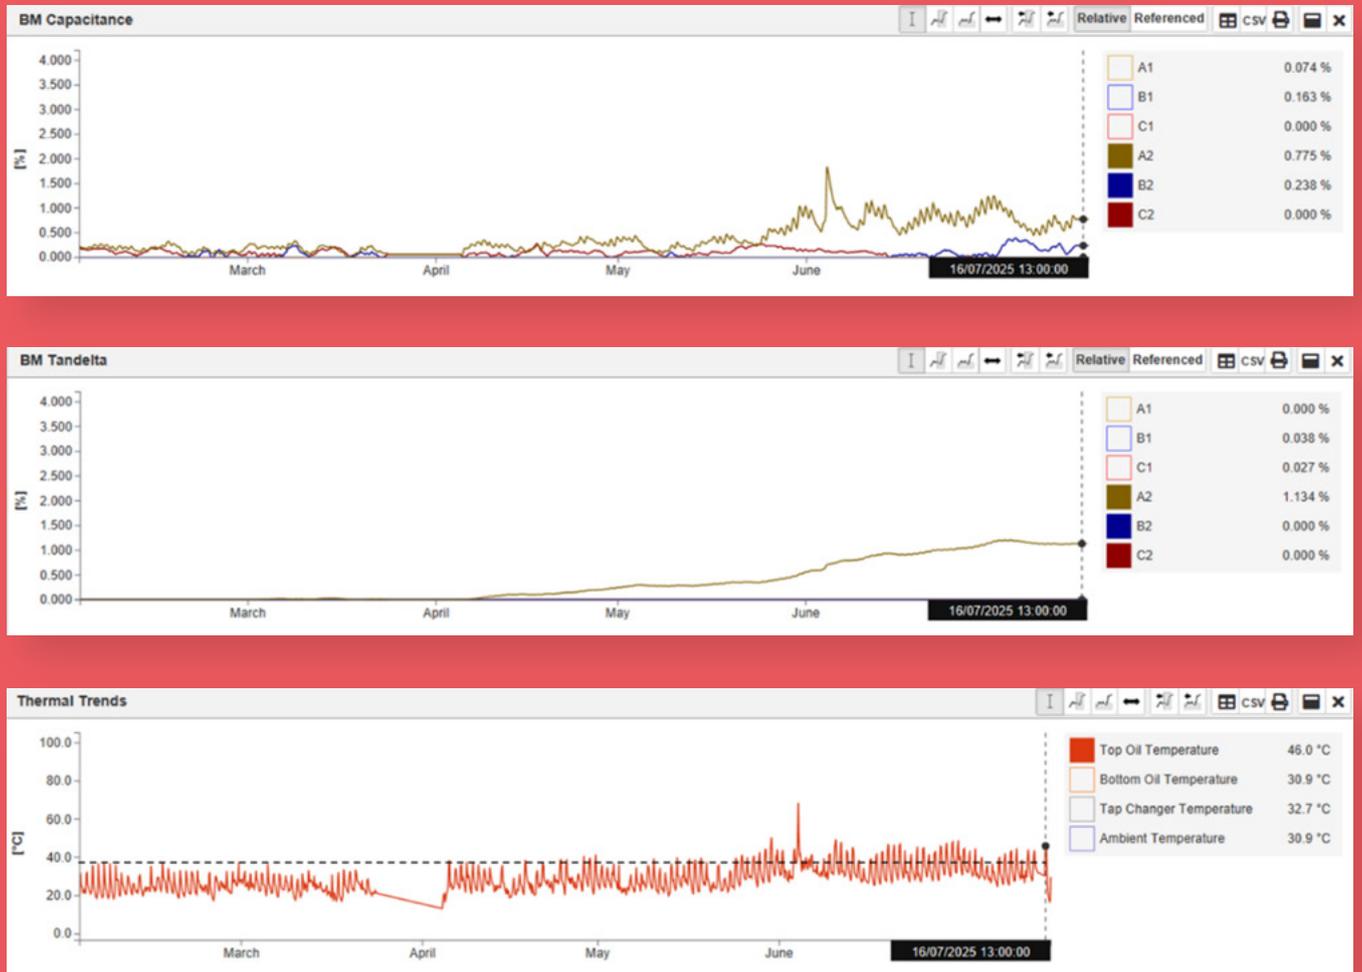
**Figure 3:**

Thermal dependency of Capacitance (top) trend and Dissipation Factor (middle) trend, with the average temperature increase (bottom).
