Cable Theft Case Study, West Coast Mainline

Signet automatically re-configures signalling power supply following cable theft incident

Location:
Nuneaton South
to Attleborough,
West Coast Main Line

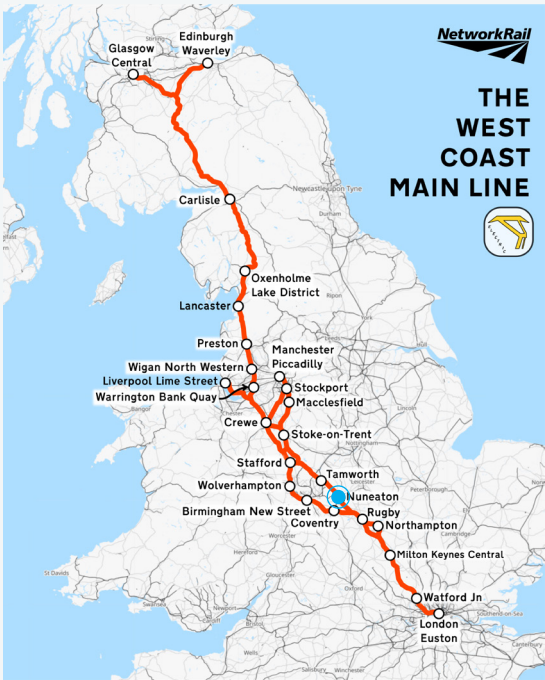
Figure 1: Feeder from Nuneaton South PSP to Attleborough PSP

The Nuneaton South to Attleborough feeder has ten Functional Signalling Point (FSP) Signets located between Nuneaton South PSP and Attleborough PSP. FSP/G/RN96M0130 was the designated open point.

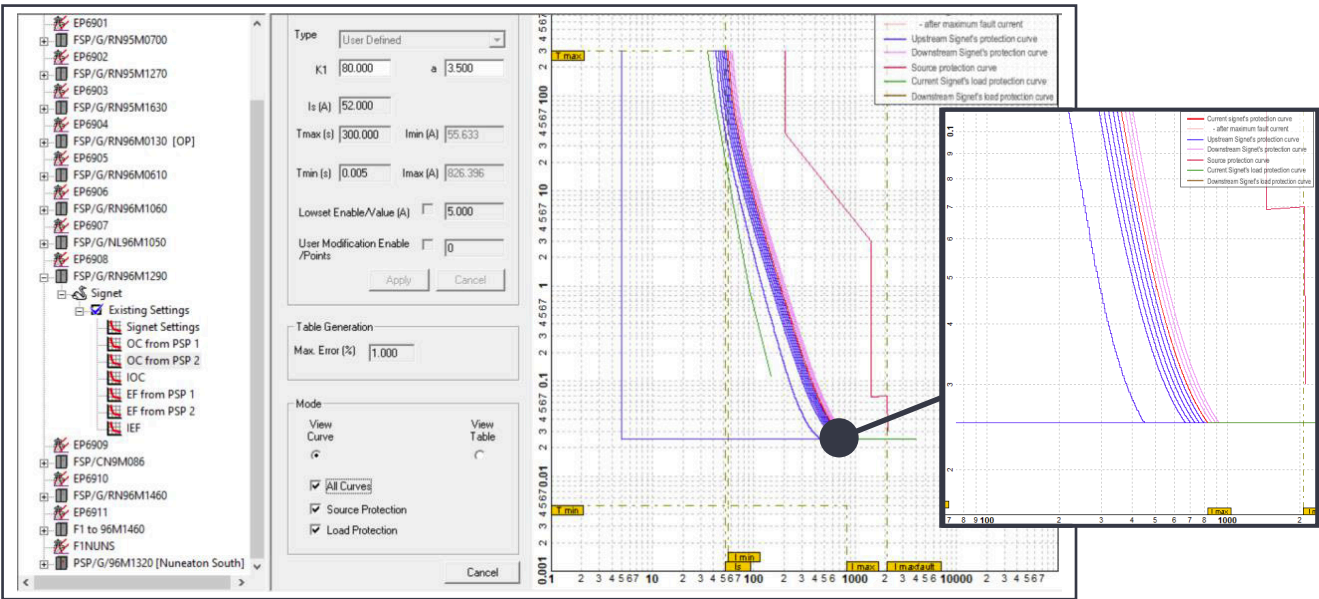
Figure 5: SIGNET discrimination curves from Nuneaton South PSP to Attleborough PSP.

Discrimination Curves in Figure 5 shows that the Signet at FSP/G/RN96N1290 measured approx. 800A overcurrent condition first resulting in a protection trip at approx. 26ms isolating the cable fault.
