KeolisAmey Metrolink_(KAM)

Pantograph Carbon Wear Case Study

KeolisAmey Metrolink & Camlin Rail

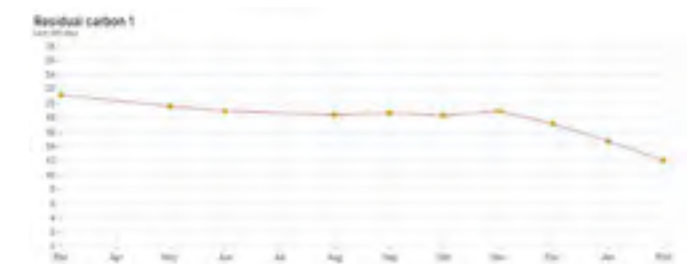
Changes in wear over a year

Graph shows the carbon wear rate is stable from March until November until a sudden increase in wear rate due to adverse weather conditions in the Winter.

Carbon wear rate is not consistent, due to several variable factors. The speed of the train, uplift and weather conditions can affect the wear rate and changes in these parameters can greatly increase the rate of wear. Manual inspection routines may not be able to detect these sudden drops, due to the infrequency of these inspections.

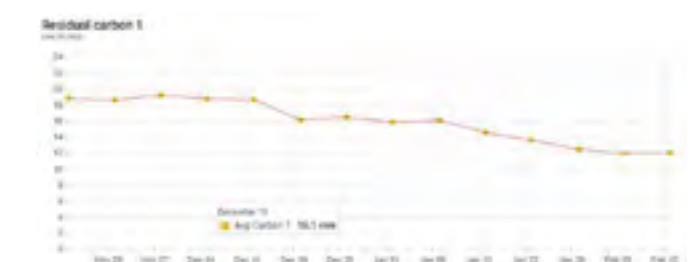
Graph shows the carbon wear rate is increased further, due to sub-zero temperatures over a one-week period. Changes in wear over 90 days

The graph shows one carriage with a drop of 3mm; however this period affected the whole fleet, with an average reduction of carbon thickness of 2mm.
