CASE STUDY

TOTUS prevents new transformer failure

Discover how Camlin Energy's online transformer monitoring solution TOTUS supports a Chinese Transmission company detect malfunctions in two young transformers, avoiding premature failure.

CHINESE TRANSMISSION COMPANY

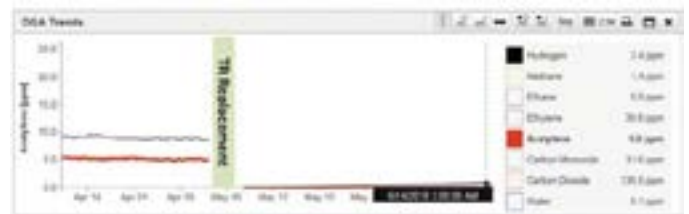
Figure 2: DGA behavior following the O&M intervention.

After the replacement took place, the monitoring system was recommissioned and left in operation to track future further changes. No further changes were recorded as reported in Figure 2.

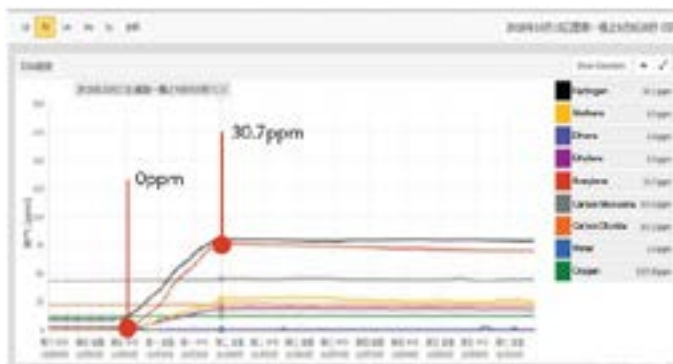
Figure 1. Offline results before and after the online alarm.

In October 2018, one of the TOTUS transformer monitors started to record an Acetylene deviation in another transformer on the same project. In this instance it was not just Acetylene that had increased, increases in other gases (Methane, Hydrogen and Ethylene) were also detected.

Within Figure 1, it must be pointed out that the Acetylene concentration rose from 0 ppm (recorded at 12:00 on 14th of October) to 30.7 ppm (recorded at 21:00 on the 15th of October) within approximately 36 hours.

The TOTUS transformer monitor issued an alarm resulting in maintenance personnel taking manual oil samples for laboratory testing (GC method used). Several manual oil samples were taken for lab analysis.
