## CONNECTING DATA TO DECISIONS

Case Studies - Volume 2

Linking Total Transformer Monitoring & Actionable Information  
to Drive Business Value for Utilities

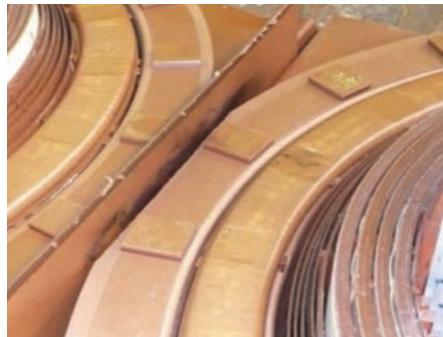
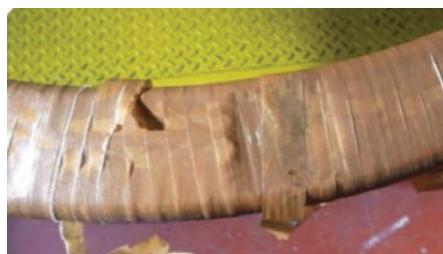
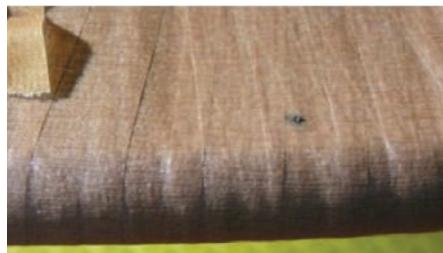
Figure 1. PD stress ring evidences, Phase U

Protrusion on cap. stress ring above HV winding, phase U.

Medium PD activity persistence > 80%.  
Located in phase U.

Manufactured in 2010, a suspect Hydrogen and Acetylene concentration was noticed in the transformer after an Oil Lab evaluation in 2011. Transformer OEM supposed stray gassing phenomena. The INTEGO TM was installed by the Utility and confirmed that cause was not stray gassing but a PD defect in one of the phases (phase U). Sporadic PD activities can where also present in phase W.

The transformer was inspected, evidences reported in Figure 1. Show the INTEGO TM provided an effective diagnosis and location thanks to the Camlin PD Triangle.

Furthermore, the INTEGO TM allowed the Distribution company to reinforce their thesis and provided proof to the OEM of the absence of stray gassing phenomena.
