Monitoring and Expert Intervention Prevents 115 kV OIP Bushing Failure

CASE STUDY

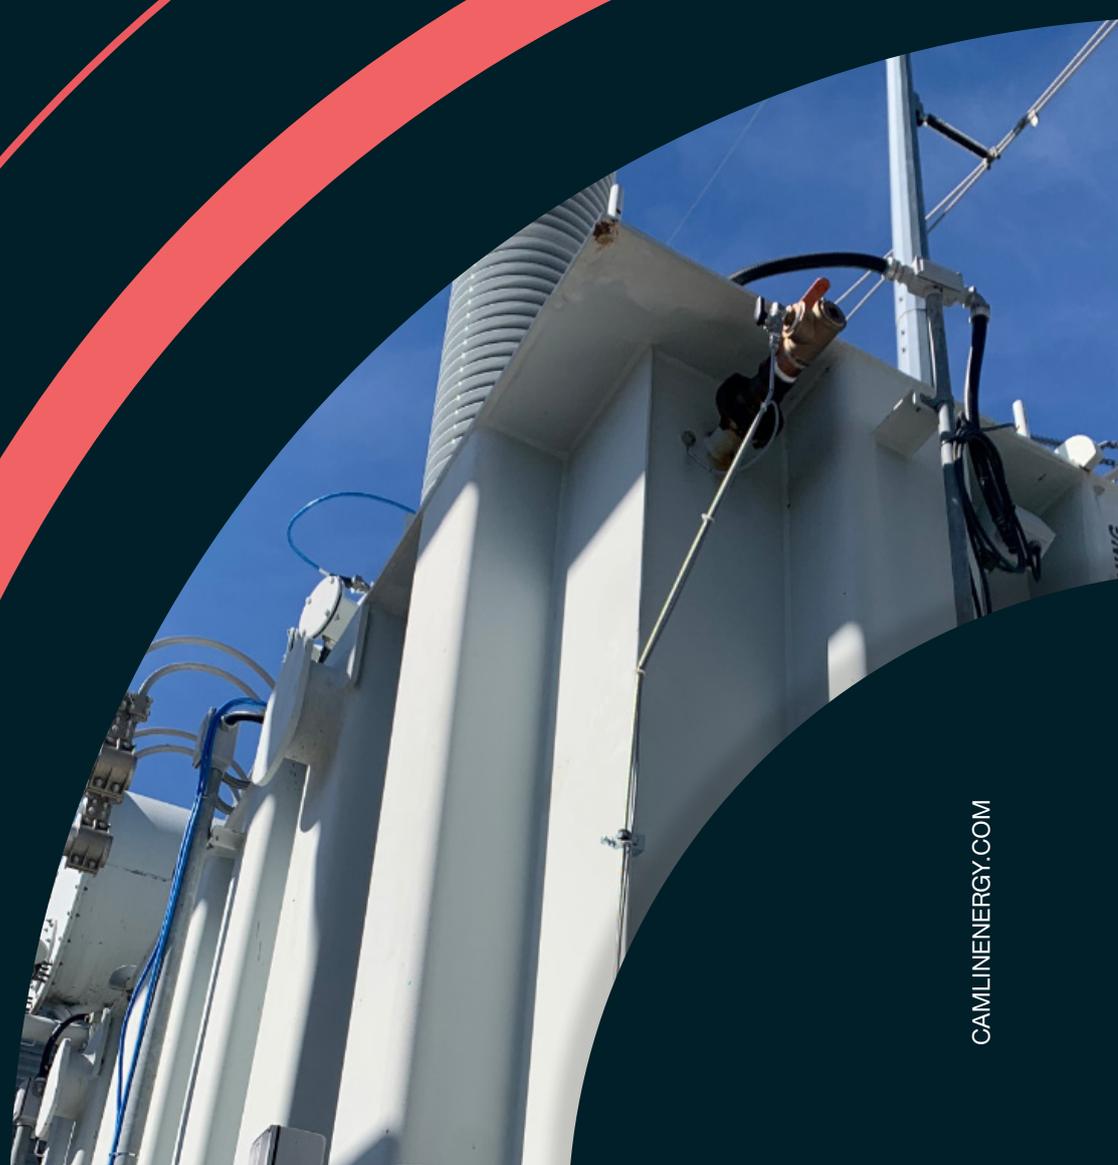
Figure 1:

TOTUS online Bushing Monitoring was installed in 2021, providing continuous measurement of PF, capacitance, and partial discharge (PD). During summer 2022, TOTUS detected elevated PF on the X1 bushing during peak top-oil temperatures. Later in the year as cooler temperatures set in PF figures lowered to normal levels, indicating a temperature-driven fault.

Camlin Energy experts analysed the data and determined that internal moisture or insulation overheating was likely causing the abnormal PF trend. Without online monitoring, these subtle yet critical signals could have been overlooked, leaving the bushing at risk of in-service failure.

TOTUS detected elevated PF on the autotransformer X1 bushing

Based on the combined TOTUS data and expert interpretation, the utility scheduled a planned outage in summer 2023 to investigate the bushing condition during a period of high ambient and operating temperatures. Offline Power Factor testing confirmed losses above 1.0%, fully validating the online indications of deterioration. With the risk clearly identified, the X1 bushing was safely replaced under controlled conditions. Continuous monitoring throughout ensured the utility could act proactively, preventing any escalation in risk.

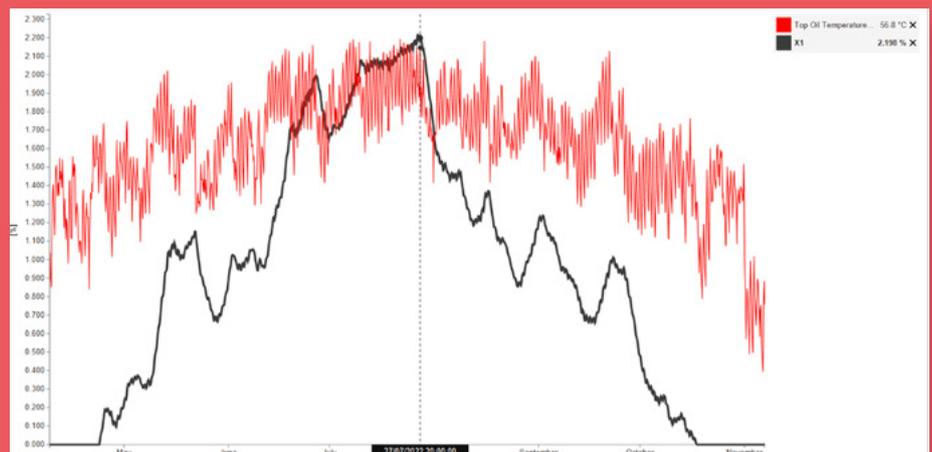
Figure 2:

Clear correlation between rising power factor and increasing top-oil temperature
