CONNECTING DATA TO DECISIONS

Case Studies - Volume 1

Linking Total Transformer Monitoring & Actionable Information
to Drive Business Value for Utilities

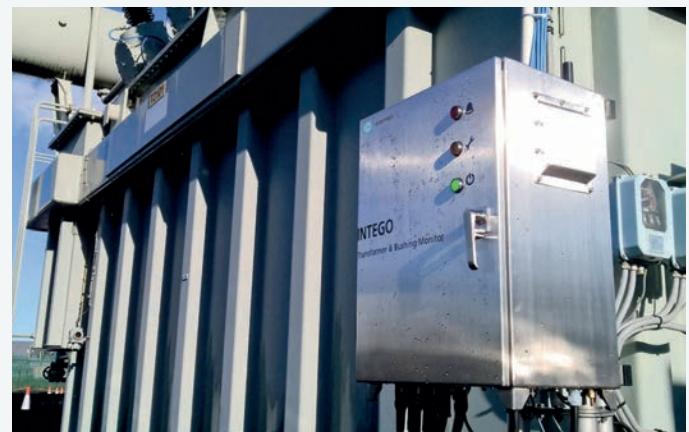
Figure 1. Capacitance increase in bushing A1 and high energy event recorded at the same time.

On February 2015, a sudden step increase of the capacitance (C1) in bushing A was detected by the monitoring system, estimating a capacitance change in the order of 1.7% which corresponds to a rough increase of 7 pF. Such a small change could have been caused by a partial short circuit between two layers in the condenser core, considering >60 control layers for 345 kV bushings. South Korean Transmission Company planned an offline test to confirm the online readings, but the results proved difficult to interpret. Indeed, the absolute value of bushing A capacitance had not changed significantly from the previous measurements, as shown in Table 1.

However, it was noticed that while the increase of capacitance in bushing A was quite small, both bushings B and C were showing a decrease of capacitance. This led to the assumption that the test setup was different when readings were taken. In order to take this into consideration, the relative difference between capacitance A and B was analysed over time. It was then possible to spot that this difference was quite constant in 2012 and 2014 (below 2 pF), while it was significantly high in 2015, exceeding 12 pF (roughly equal to 2.7% of capacitance increase).

It was then found that at the precise moment of the bushing capacitance increase, a high energy event (partial discharge activity with significantly high magnitude, generally equal or higher than 20 V peak-peak [6]) was recorded in the same phase (from same sensor) by the online monitoring system. In this case, the recorded event had just 8 pulses per second and it happened just once. The fact that this event was recorded in conjunction with the capacitance increase was an important detail that prompted an additional offline test: oil sampling from the bushing and Dissolved Gas Analysis (DGA). Table 2 reports the results of the DGA analysis for bushings A and C. It can be clearly seen that the amount of acetylene in bushing A is well above the tolerance values, being 76 ppm; while level of acetylene in bushing C was zero, as expected.

Following the results shown in Table 2, South Korean Transmission Company promptly planned and executed the bushing replacement within a few months, thus saving the bushing from a potentially catastrophic incident. It must be noted that both the capacitance change and the repetition rate of the high energy event were quite small in terms of absolute magnitude. But being able to detect both these phenomena online and see that they occurred in the same moment provided crucial information enabling South Korean Transmission Company to take a very successful action.

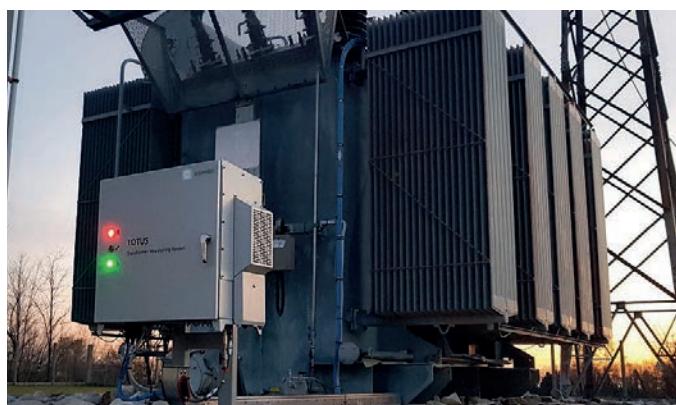
Figure 1. Online holistic monitoring system installed in 25 MVA GSU

- Oil degassing. The transformer had a history of abnormal but stable levels of hot gases due to a thermal issue such ethylene and methane. The fact that the gases were stable for a long time indicated that the defect was likely not active anymore.
- Replacement of the glass inspection window in the bushings. The transformer was originally not equipped with any monitoring system. After the maintenance, an oil sample was taken which showed abnormal levels of H₂ in the range of a few hundred ppm. The OEM speculated that this could have been related to the same defect that generated the ethylene increase previously and was likely to be associated with hot spots.

Since the new gas pattern was not actually showing "hot metal" gases and considering that the H₂ increase was significant and coincidentally occurring right after the maintenance, the generation company suspected that the defect was somehow related to the latest maintenance. The utility equipped the transformer with a comprehensive transformer monitoring system that included a five-gas monitor and modules for monitoring moisture, partial discharges, and bushings, as well as analytics capabilities and temperature readings.
