Early Detection and Replacement Saves Two 69 kV Bushings for APAC Utility

CASE STUDY

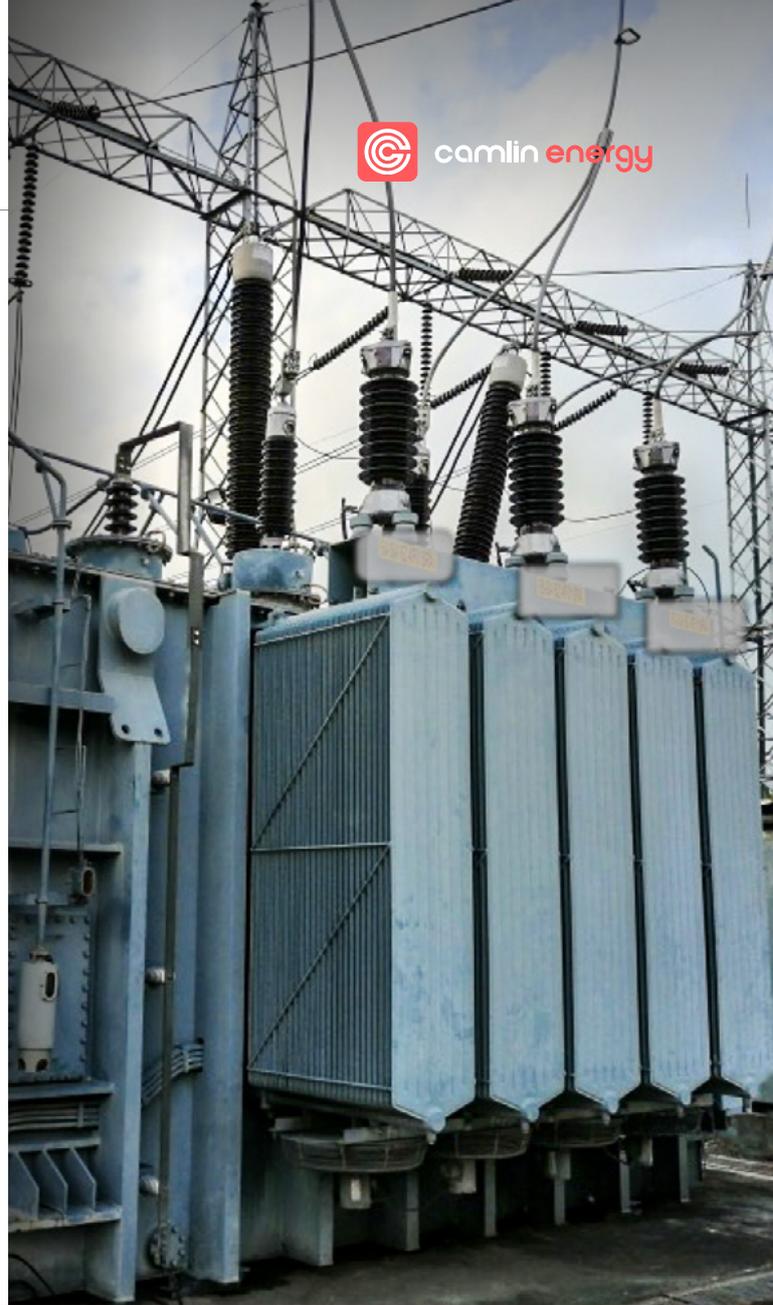
With the visibility of data provided by TOTUS, the utility de-energised the transformer and carried out targeted offline testing. This confirmed abnormal Power Factor readings on two bushings, 3.0% on A2 and 1.8% on C2, indicating emerging insulation deterioration. Based on this evidence, the utility prioritised proactive replacement of both bushings before an in-service failure could occur.

By acting on validated risk rather than waiting for a fault, the utility was able to take planned, controlled action instead of responding to an emergency event.
