# A €9,000 Intervention That Prevented a €2M Catastrophic Failure for a Leading French Utility

CASE STUDY

Preventing Transformer Failure in a Critical Hydro Asset

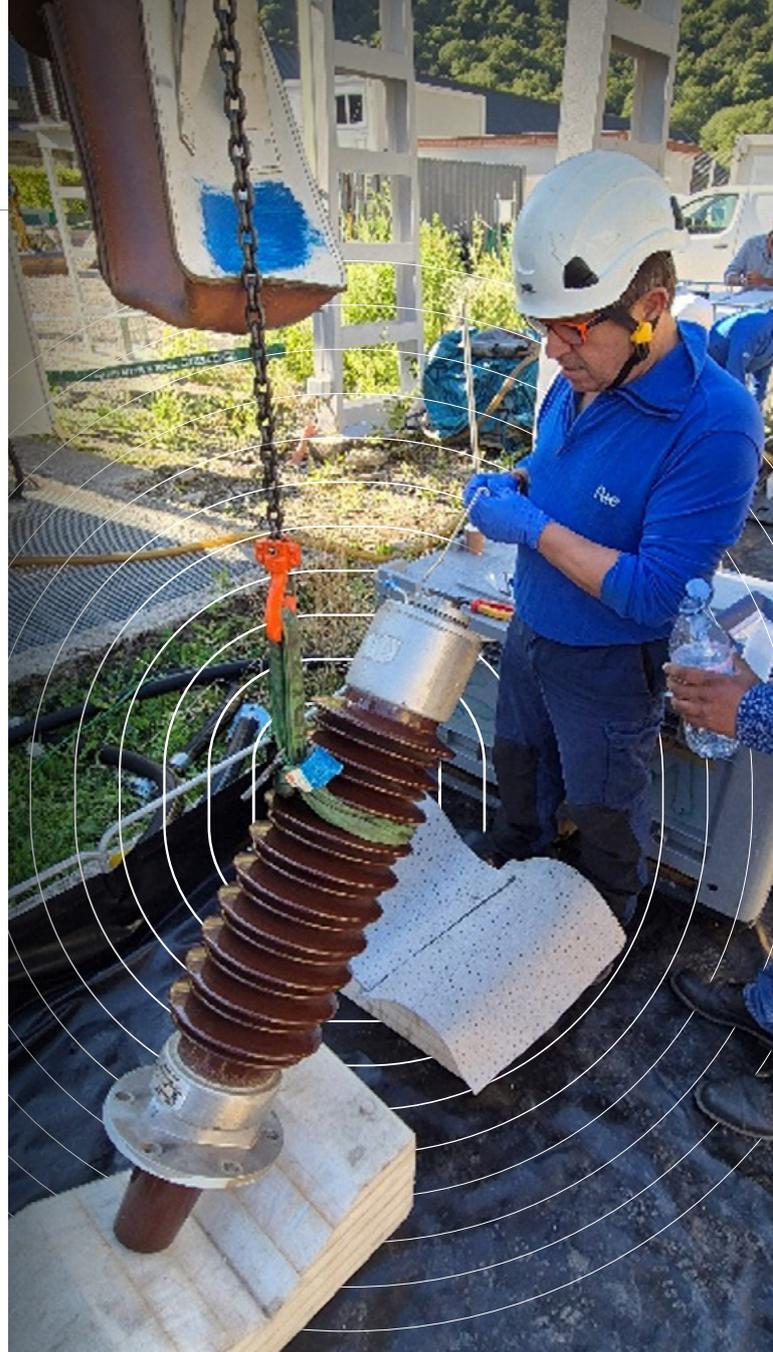
During the scheduled outage, the French utility conducted detailed offline testing to verify the condition of the bushings. On the A2 bushing Dielectric Frequency Sweep testing was performed returning a dielectric factor of 2.6287%, a value classified as extreme according to CIGRE 755 guidelines.

A fixed frequency voltage sweep showed a Power Factor of 1.4215% (approximately 6.5 times the nameplate value), indicating severe dielectric deterioration. Dissolved Gas Analysis further supported these findings, revealing elevated levels of hydrogen, methane, and ethane consistent with internal insulation degradation.

Based on this evidence, the defective A2 bushing was removed and replaced, and an internal investigation by the OEM is underway to determine the root cause of the failure.
